**National Highway
Traffic Safety
Administration**

Case Vehicle (A): 1998 Buick
 Type: Century Custom, 4-door sedan
 Driver: 70-year-old female
 CDC: 12-FDEW-2, 00-TDDO-4

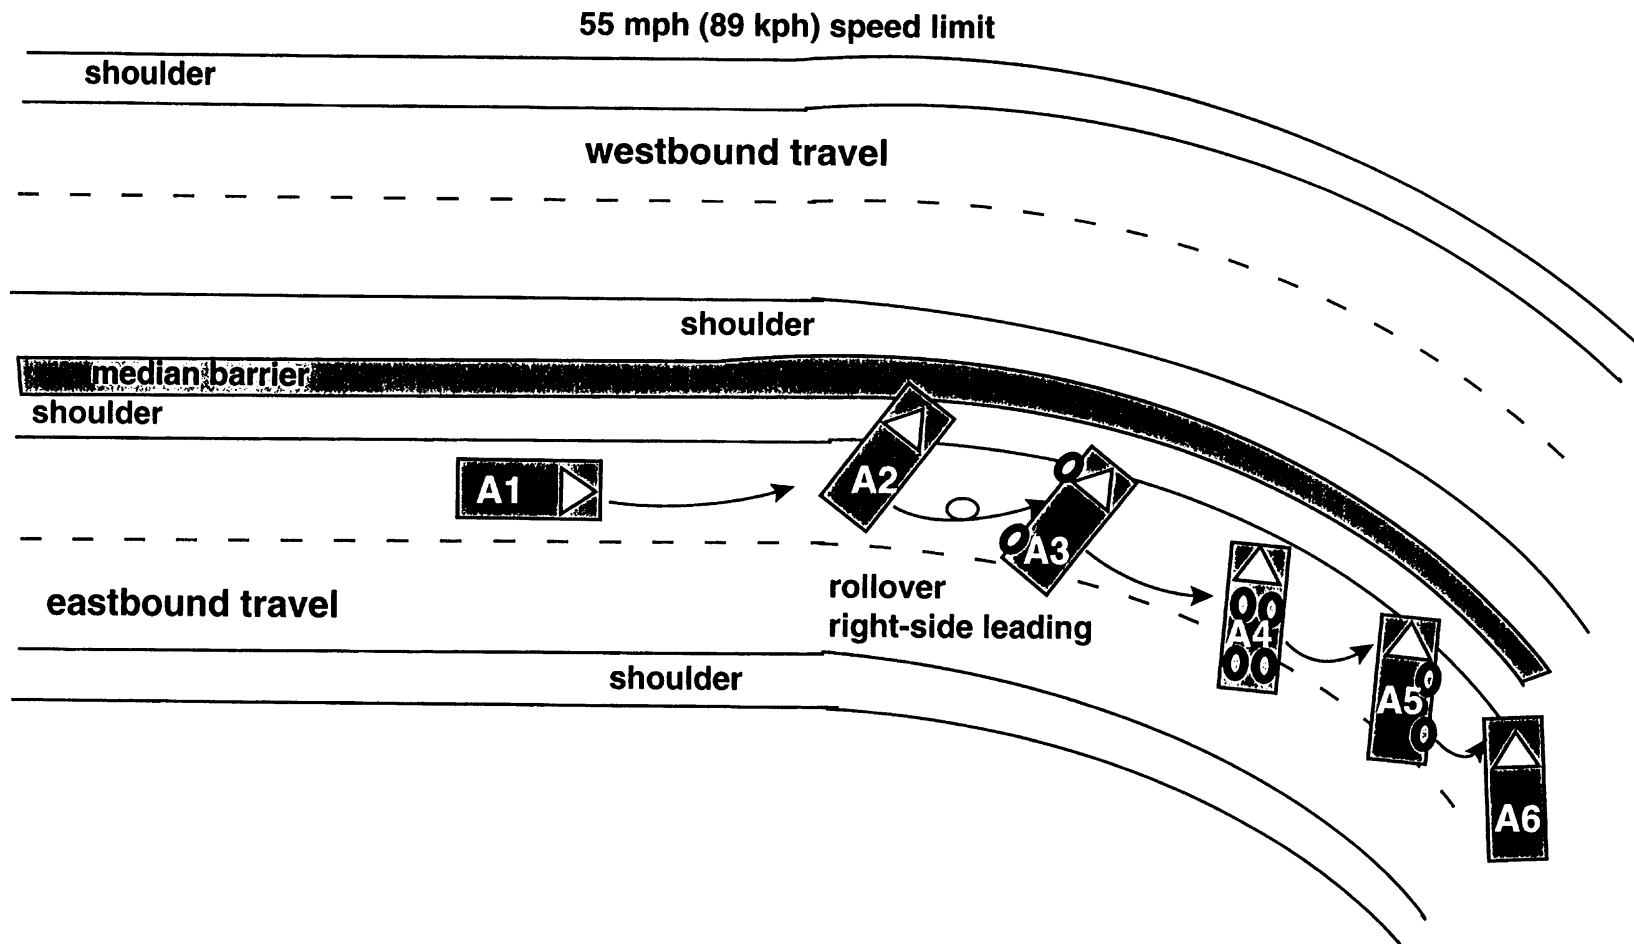
ACCIDENT SCHEMATIC

ACCIDENT DESCRIPTION: CASE VEHICLE (A) WAS TRAVELING EAST AT AN UNKNOWN SPEED IN THE LEFT LANE OF A LIMITED-ACCESS HIGHWAY. THE DRIVER REPORTEDLY FELL ASLEEP WHILE DRIVING, EXITED THE LANE LINE AND NORTH SHOULDER, AND STRUCK A CONCRETE BARRIER WALL WITH ITS FRONT. AFTER THE IMPACT, THE VEHICLE ROLLED OVER AT LEAST 360° WITH ITS RIGHT-SIDE LEADING. IT CAME TO REST ON ITS WHEELS.

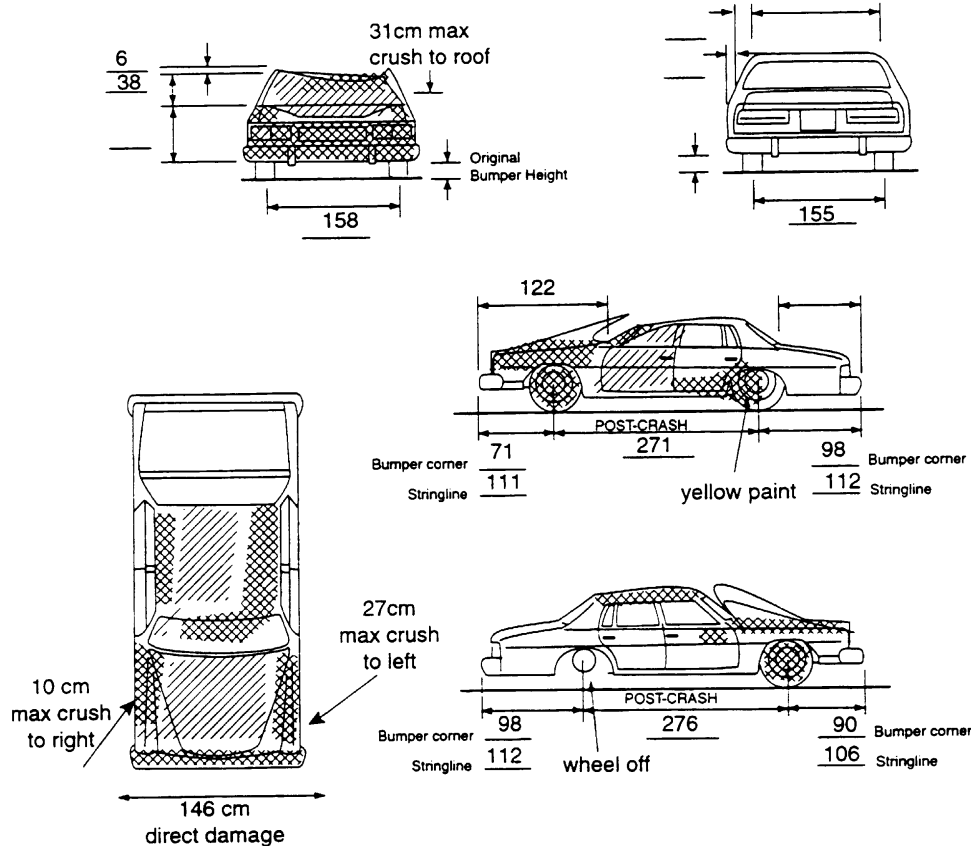
VEHICLE DAMAGE

Direct Damage Length (DDL) 146 cm
35 37

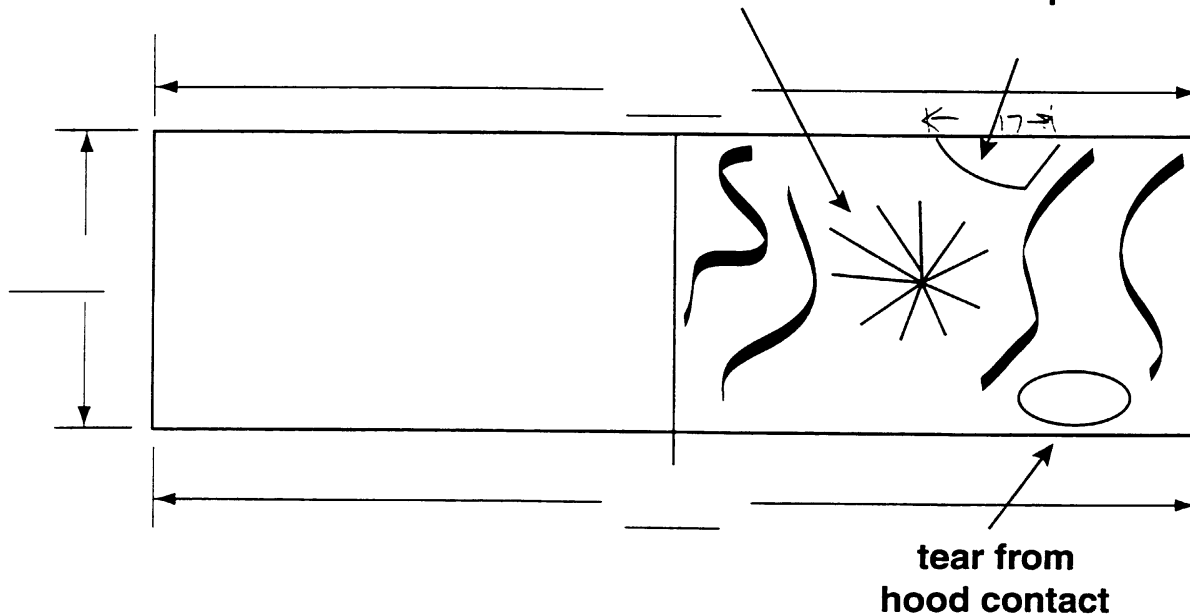
LOCATE AREA OF WINDSHIELD INTEREST OR DAMAGE WITH DIMENSIONS (VERTICAL
 & HORIZONTAL) ON THIS DIAGRAM OF THE WINDSHIELD AS VIEWED FROM INSIDE.

airbag cover
 contact

bond separation

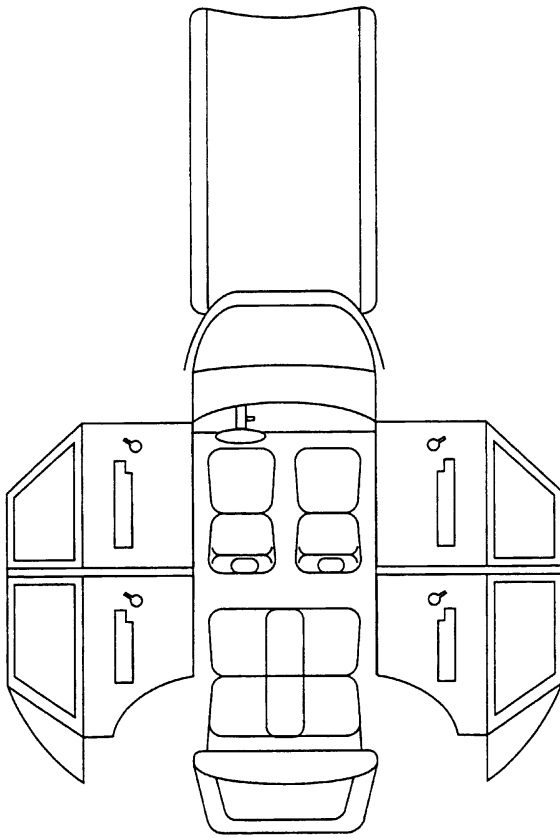
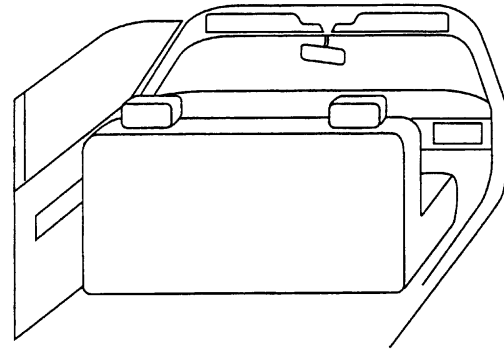
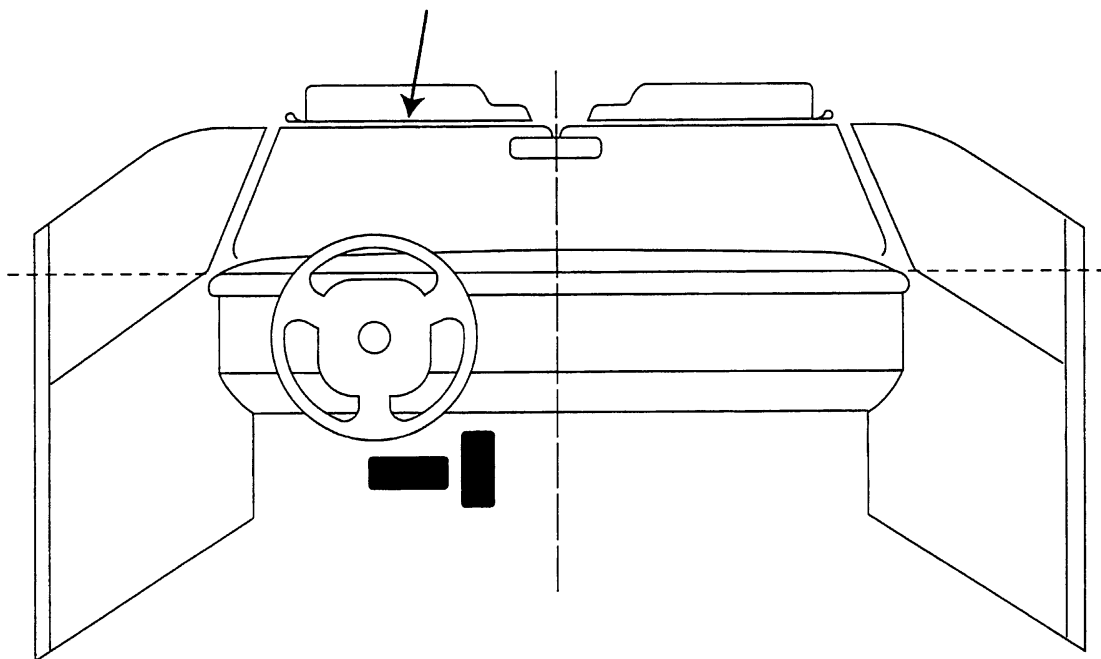
VEHICLE OCCUPANT CONTACT DIAGRAM

Contact	Interior Component Contacted	Occupant No. if Known	Body Region if Known	Supporting Physical Evidence	Confidence Level of Contact Point
A	Sunvisor	1	Head	Hair	1
B					
C					
D					
E					
F					
G					
H					
I					
J					
K

DR BELT: adjusted to
low position on B-pillar

(A) sunvisor

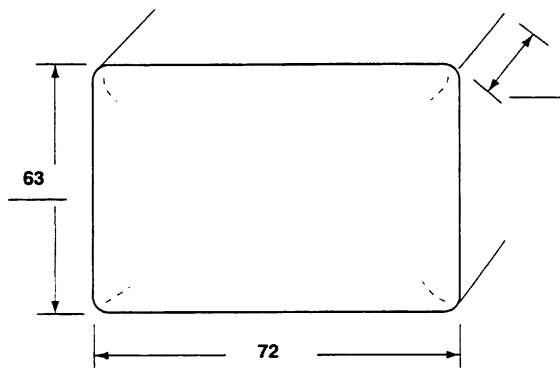
Passenger Airbag

Flap contacted windshield

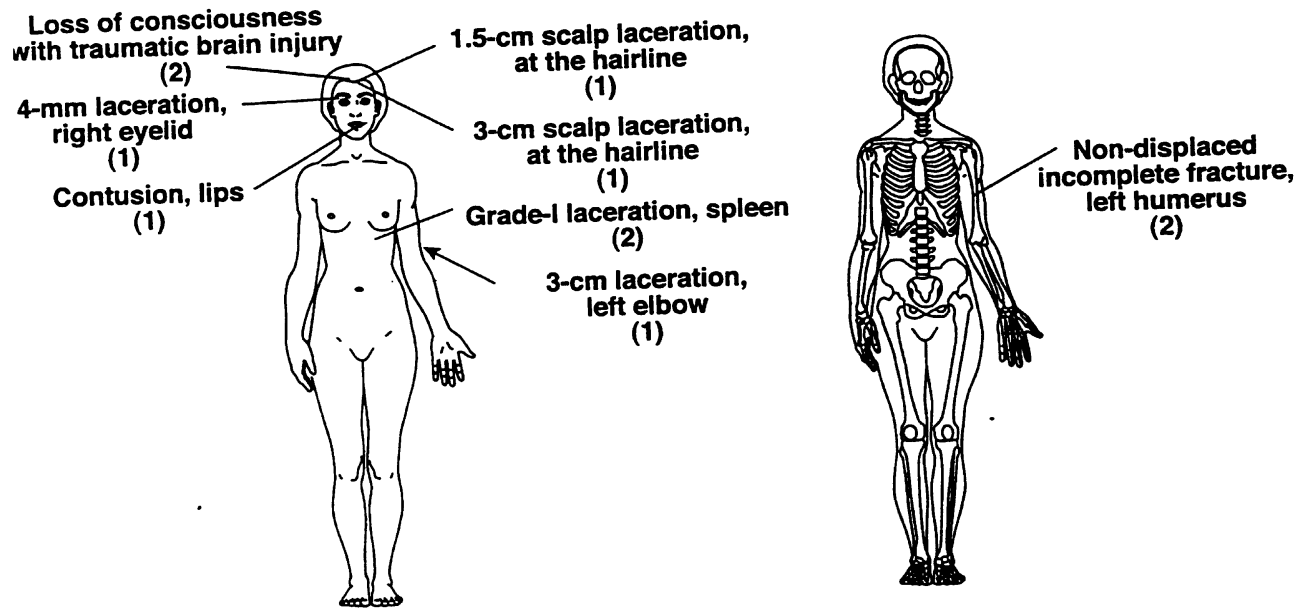
INDICATE LOCATION OF INJURIES.

Non-displaced
incomplete fracture,
left humerus
(2)
